U.S. Army  
Coastal Engineering  
Research Center

CONCRETE BLOCK REVETMENT  
NEAR BENEDICT, MARYLAND

MISCELLANEOUS PAPER No. 1-64  
January 1964

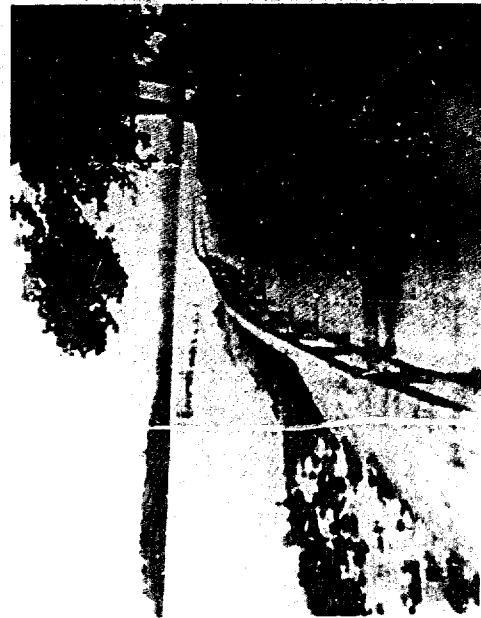
A - Looking north near northern end of revetment

B - Looking south midway along revetment

C - Looking north midway along revetment

D - Looking south near southern end of revetment

FIGURE 7 COMPLETED CONCRETE BLOCK REVETMENT - JULY 1962

Construction was started in early May and completed in July 1962. Figure 7 shows views of the completed revetment. A railing was placed along the top of the revetment as a safety measure.
